## *1. Introduction*

The current research has two main objectives. The first objective consists of the evaluation of the potential harming effect of some packing lines from some cooperatives in the region of Murcia with the aid of Instrumented Spheres IS-100. The second one looks forward studying the influence of one packing lines on different stone fruit varieties under the point of view of mechanical damage.

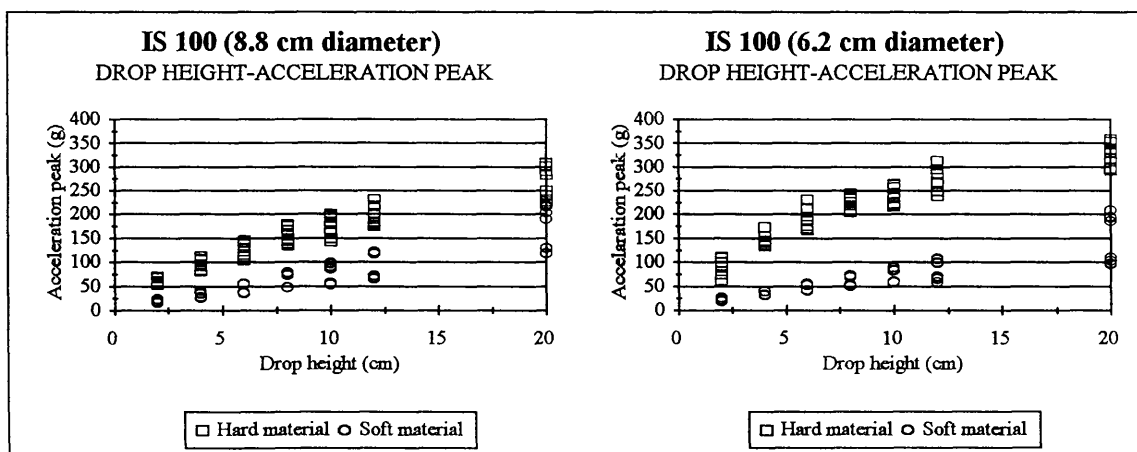
Fig 1. Comparison between big and small IS 100. For same impact conditions, the 6.2 cm Ø IS registers similar acceleration peak values for soft materials as the 8.8 cm Ø IS, but higher values of the same variable for hard surfaces.

Both IS measure the same values of the same variables for soft materials, but not for hard surfaces. They must have been calibrated for soft materials and not for hard ones. The 6.2 cm Ø IS, for identical impact characteristics, registers higher 'acceleration peak' values than the big one (fig. 1). This could be due to the different dimensions of both devices, what oblies them to move in a different way through the line. Considering that the small one is more similar to the tested fruits in terms of dimensions, and subsequently movement through the line, than the orange-like one, in these previous results we will pay more attention to the results registered by the small sphere. In any case, results of both IS are refered in this paper.

1. Although both IS are supposed to measure the same values for identical impact conditions, they register similar ranges for soft materials but not for hard materials.
2. Most transfers in the tested lines must be revised. They include high impact probabilities, being these impacts highly dangerous because of their intensity.
3. Further tests must determine proper regulations of each transfer and for each product in terms of distance between consecutive elements, speed of the elements, etc.
4. More than 50% of mechanically handled fruits show some kind of damage. These bruises evolve significantly after 48 hours at room temperature. This is a consequence of the bad state of the lines.

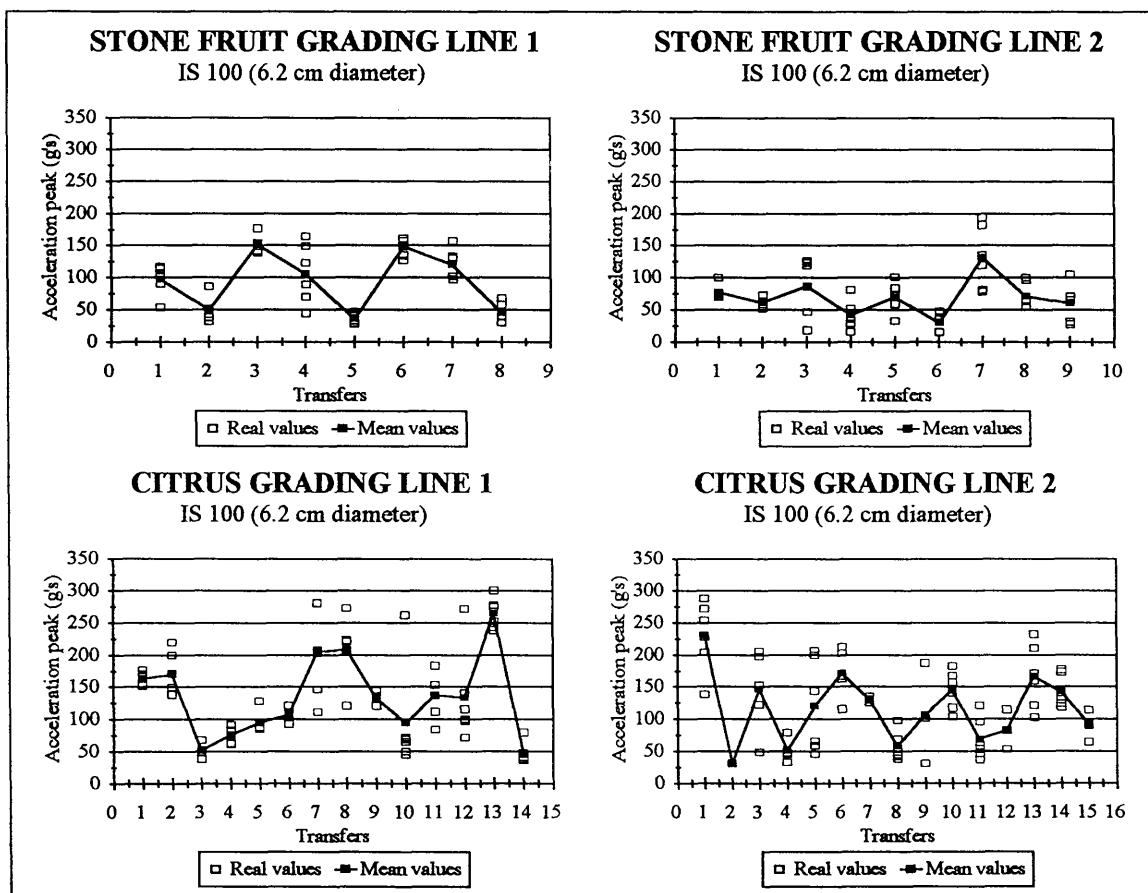
Fig. 2 Profile of acceleration peak values of tested varieties. Citrus grading lines show much higher values than stone fruit grading lines. 'Real values' are the measured data in each run and 'Mean values' are the average value of six runs.

IS values obtained in transfers belonging to the tested lines lay well above 50 g's in most of them. Barreiro reported that an impact of 50 g's means a 50 mm<sup>2</sup> for stone fruit (Barreiro, 1995), being this section value the maximum allowable damage surface by EC standards for Class I of this product (fig. 2). Although there is a high variability for the data registered in each tranfer (six runs were made per line), the average impact values are most of them above this risk threshold.

As seen in fig. 2 and with the information of Table 2 we conclude that citrus lines are generallyly worse designed and/or regulated than stone fruit lines. Much higher impact intensities are registered in these lines than in the stone fruit lines.

The design of the elements is also of capital importance. Dumping is one of the more dangerous transfers in almost every line (see transfer 1 in fig. 2). Through an optimal design of this element, high intensity impacts can be avoided (see transfer 1 in fig. 4 and photos 2 & 3). The data shown in fig. 4 correspond to the dumper of photo 2. This is an example of a good design. The 8.8 cm Ø IS did not register any impact at this point; the 6.2 cm Ø IS registered in one of the run a maximum acceleration peak of 32.9 g's. Photo 3 is an example of a bad design. This kind of dumper is the most usual model. The acceleration peak mean values for this kind of dumper vary between 53 and 157 g's for the big IS and between 77 and 231 g's for the small IS.

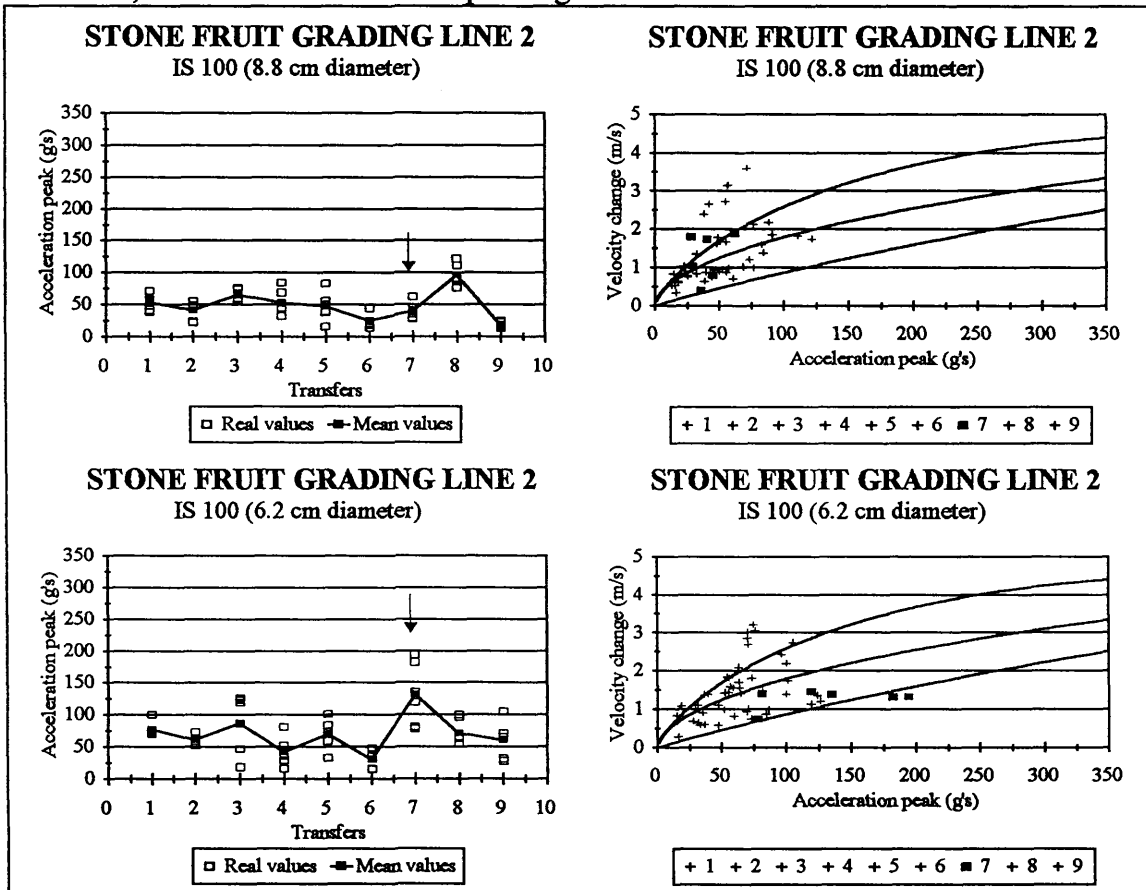
Fig. 3. Comparison of the effectiveness of transfer 7. It decelerates big fruits properly but makes no effect on smaller fruits, letting it go through it at high speed.

Through a good design and a proper regulation of transfers it is possible to decrease the number and intensity of impacts. In fig. 3 it is shown that transfer 7 (transfer from a rollers elevator to sizer cups, photo 1) is effective as deceleration element for a big fruit (8.8 cm  $\varnothing$  IS) but not for a small one (6.2 cm  $\varnothing$  IS); the corresponding 'acceleration peak' mean values for both spheres are 44 g's and 130 g's respectively. The cushioning device is effective for the big sphere because it wraps it all around. However the distance between this element and the opposite supporting element is too large and lets the 6.2 cm sphere go through them, without wrapping it and decreasing its speed. In the graphics placed in the right of figure 3, 'acceleration peak' vs 'velocity change', it is clearly seen that the big sphere impacts against a soft element in transfer 7, whereas the small one impacts against a hard surface.

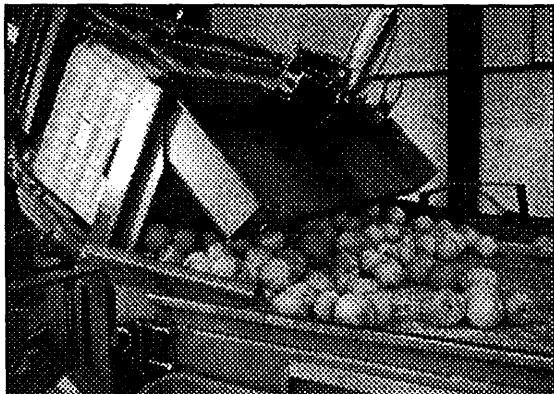
Photo 2. Good dumper

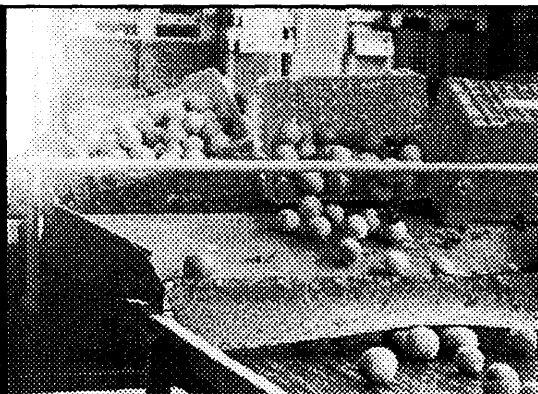
Photo 3. Bad dumper

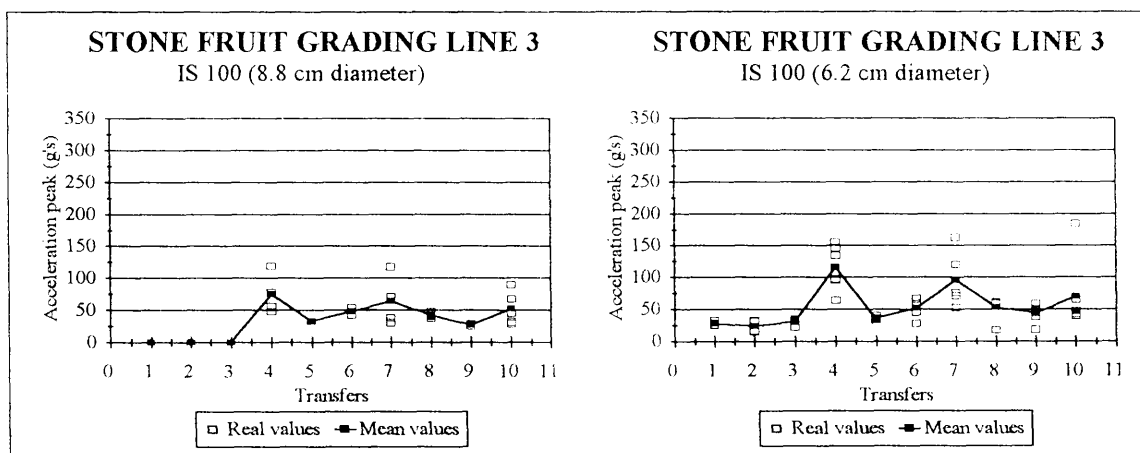
Fig. 4. Grading line of a stone fruit packing house. Low dumping impact intensities.

The speed of the elements (conveyors, rollers, sizer cups, etc) plays also an important role in impact intensity and, subsequently, in bruises appearance. Low speeds and, over all, low speed differences between consecutive elements reduce substantially impacts incidence (figs. 4 y 5). Although the speed of the elements is not the only influence factor, first elements of line Stone 3 present low and similar speeds; consequently both IS registered low acceleration peak values (fig. 4): the big IS did not register any impact in the three first transfers, while the 6.2 cm Ø IS registered 28.04, 13.9 and 31.2 g's as acceleration peak mean values respectively.

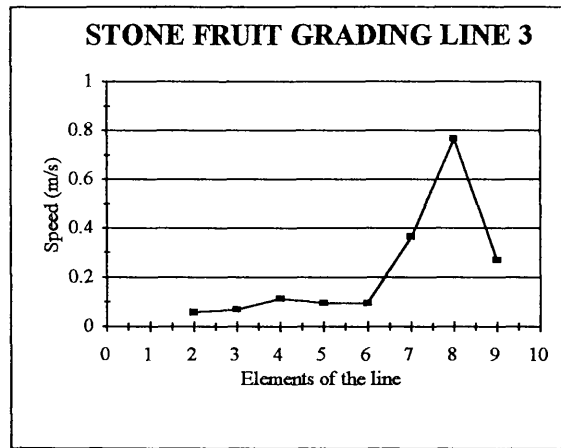
Fig. 5. Speed of the elements of stone fruit grading line 3

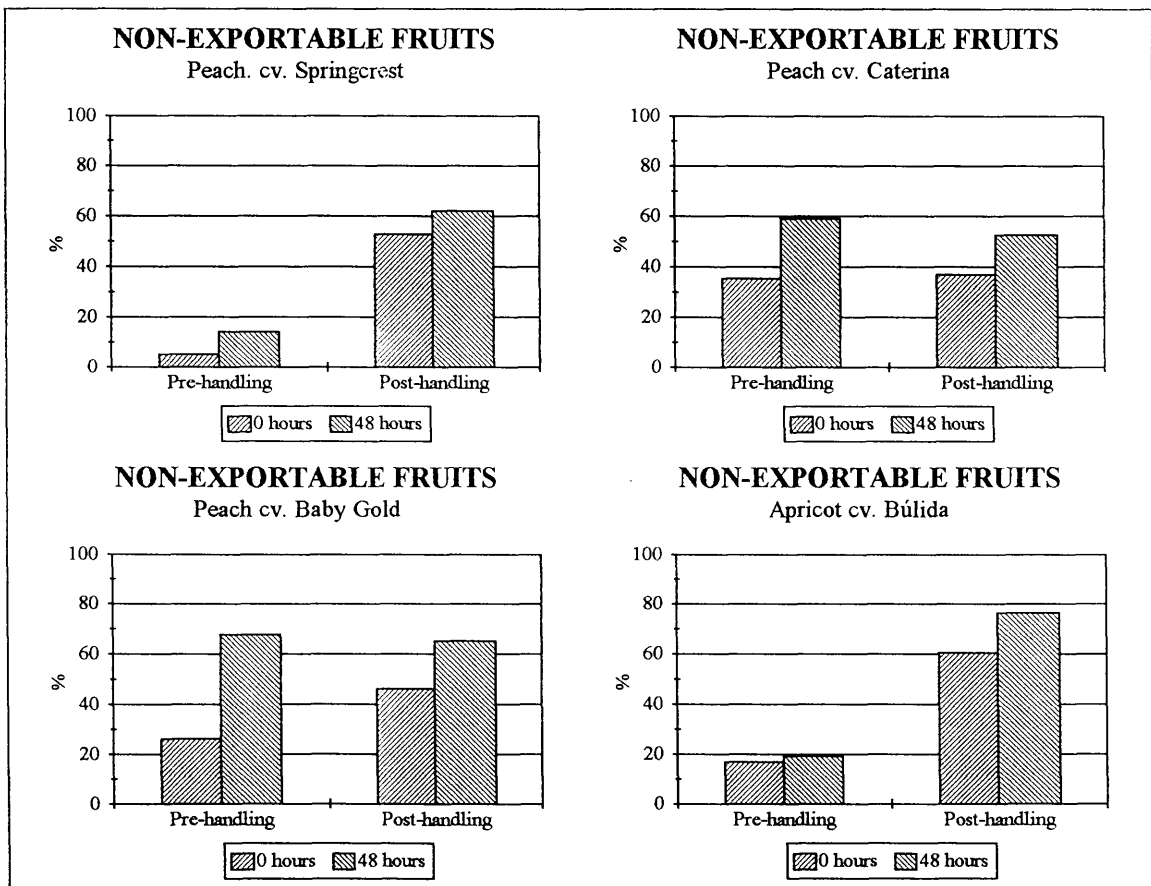
Fig. 6. Percentages of 'non-exportable' fruits ( $\approx$  fruits out of Extra or Class I categories, according to UE Standards) before and after handling.

In all cases more than 50 % of fruits belonging to the post-handling sample showed some kind of damage. Considering only the percentages of out of Extra and Class I fruits, than mean the non-exportable ones, they vary from 37% of *Caterina* peaches up to 61% damaged fruit of *Búlida* apricots. After 48 hours storage, these percentages varied between 53% (*Caterina* peach) and 76% (*Búlida* apricot).

Fig. 6 shows that bruises do evolve after 3 48 hours storage at room temperature ( $\approx 20^{\circ}\text{C}$ ) in every tested variety, increasing the percentage of out of Extra and Class I fruits, according to UE Standards.
